Circle the Wagons: The History of US Army Convoy Security

Richard E. Killblane

Combat Studies Institute Press
Fort Leavenworth, Kansas

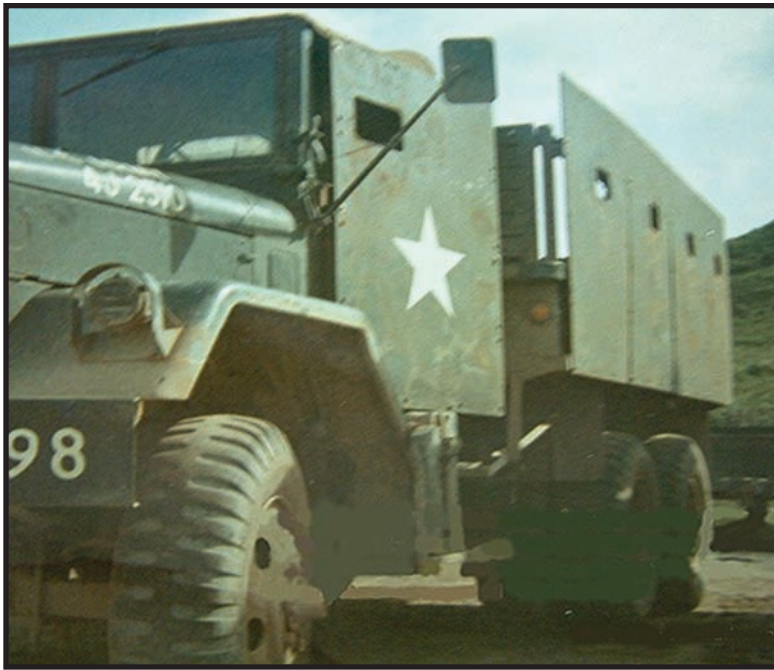
Figure 5. The First Gun Truck.

Credited to J.D. Calhoun.

during World War II; yet, the 8th Group did not have ring mounts and the depot units had no idea what they were and could not order them. As a substitute, Wolfe thought of constructing sandbag pillboxes on the backs of 2½-ton trucks and placing one man in each with an M-60 machine gun. Lieutenant Colonel Phillip N. Smiley, Commander of the 27th Battalion, directed his battalion to build the first two gun trucks.⁴

To protect themselves from mines, the 8th Group crews added sandbags to the floor of their trucks, on the hood in front of the windshields, and even on the fenders. The latter did not work because of the engine's heat and vibration. Warrant Officer Nichols, the group maintenance officer, decided to place steel plating on the sides of the trucks for protection.

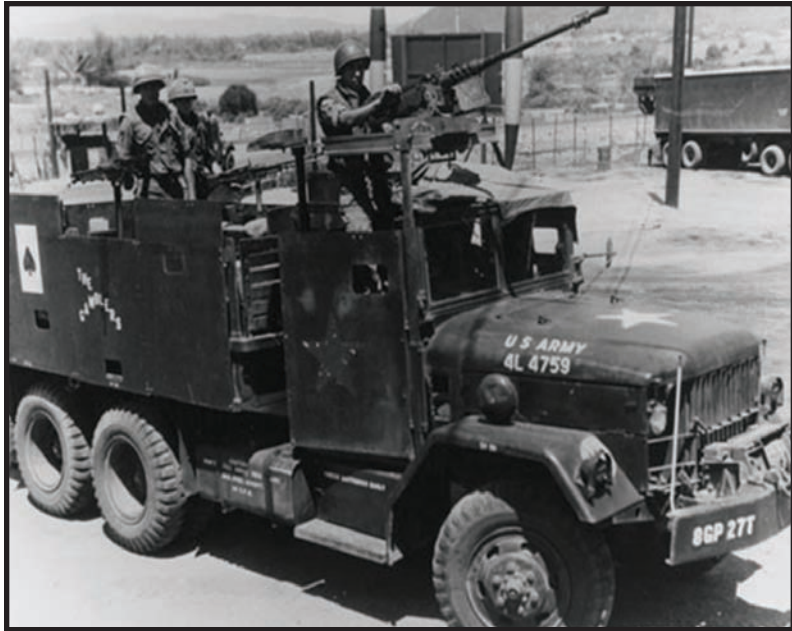
Figure 6. 8th Group 2 1/2-Ton Gun Truck with Steel Plates. This truck has sandbagged floors and two pedestal-mounted M-60 machine guns.

Soldiers scrounged around for plates, finding enough for three to four trucks. This was not the first attempt to harden vehicles in Vietnam. Captain John Horvath, Commander of the 64th Medium Truck Company, had fully armored his convoy commander jeep in the fall of 1966. The 54th Battalion ordered more ring mounts and steel plates, though the plates did not arrive until September. Up to that point, the enemy threat did not generate a greater sense of urgency.⁵

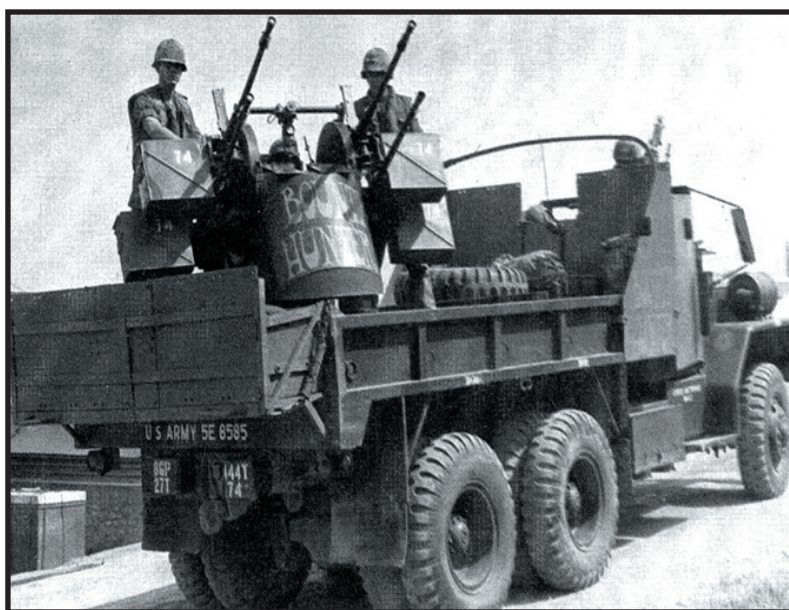
Figure 8. *The Bounty Hunter's* Mounted Quad .50 Caliber.

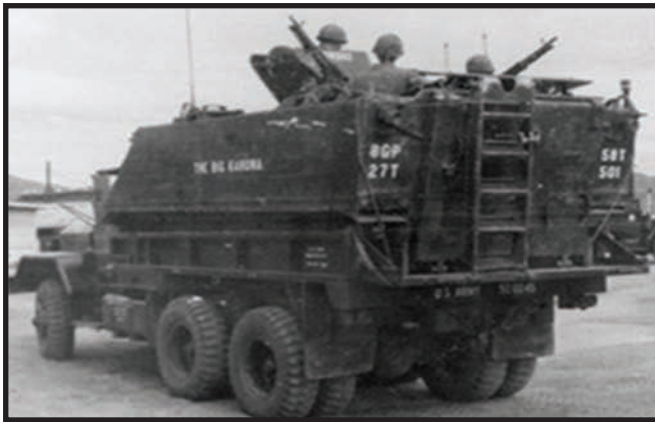
Figure 14. *The Big Kahuna*. APC hull mounted in a 5-ton truck.

This steel shortage caused Bellino to experiment with another idea. 8th Group mechanics mounted a stripped-down APC hull on the back of a 5-ton truck with an M2 .50 caliber and two M-60 machine guns on the top. 8th Group first fielded several APC gun trucks in September 1968. Experimenting further, 8th Group mounted the hull on just the frame of an M54

5-ton truck and another on the bed of a 5-ton. The one loaded on the bed worked best. Colonel Bellino thought this third iteration of gun truck would replace the other types. Unfortunately however, the APC gun truck proved to be very top heavy, hard to drive, and dangerous on turns. The crews of the 8th Group loaded their APC hulls with front forward. This placed most of the weight over the back wheels. The crews down at Cam Ranh Bay loaded their APC hulls in backwards. This distributed the weight more evenly over both the front and rear wheels. Even so, the excessive weight was hard on the vehicle since it required more maintenance to keep it road ready. Its armor offered less protection than double steel panels with filler material and it did not have the firepower of a box-type gun truck. By 1970, complaints had reached 8th Group headquarters, who decided to eventually discard the APC gun trucks. A few did survive in I Corps. The box-type gun truck remained the favorite among crews.⁴⁶

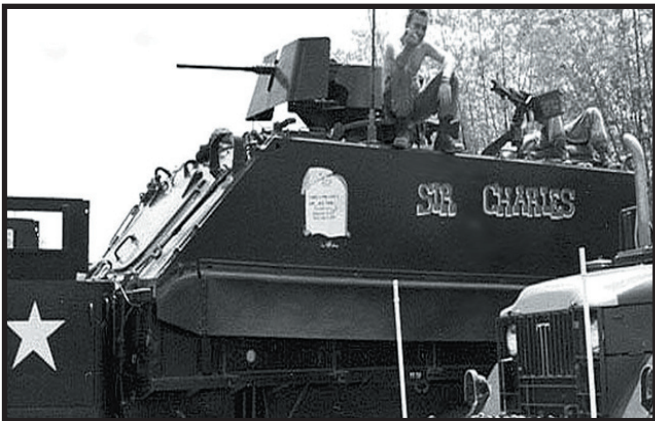
Figure 15. *Sir Charles*, M113 APC Hull.

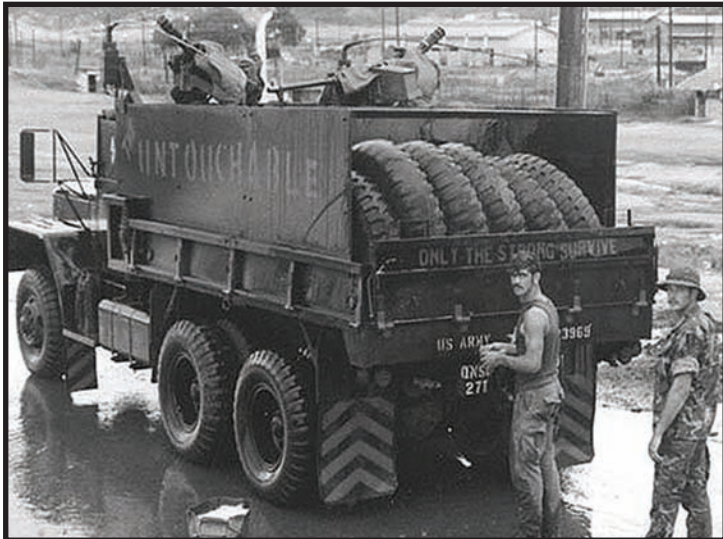
Figure 18. *The Untouchable*, M134 Gatling Machine Gun.

Armament evolution began with hand-carried M-60 and ring-mounted .50 caliber machine guns. Gun truck noncommissioned officers in charge (NCOIC) learned that ring mounts could not effectively traverse 360 degrees, so that machine gun was moved to a pedestal in the box. It was also discovered that the peripheral vision of two men did not encompass 360 degrees. Therefore, the gun truck progressed to a crew of three men in the box. Soon crews mounted all machine guns on pedestals for control and accuracy. As had been learned by earlier truck drivers in the Korean War, the .30 caliber and later 7.62mm (M-60) machine guns were not nearly as intimidating as the M-2 .50 caliber (see Figure 17). The .50 caliber machine gun could shoot through almost anything. By 1969, crews replaced their pedestal mounted M-60s with .50 caliber machine guns or even M134 7.62mm Gatling machine guns, or mini-guns. The mini-gun was the most intimidating, but it tended to jam (see Figure 18). Gun

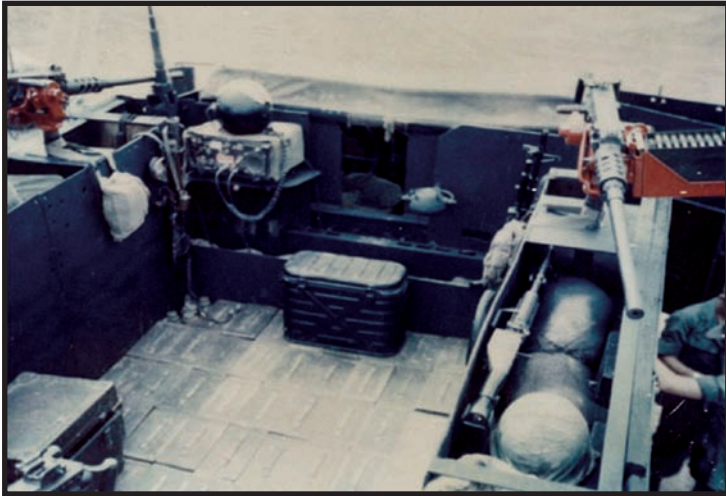
Figure 19. Ammunition-Laden Gun-Truck Floor.

Another important factor adding to the gun truck’s firepower was the amount of ammunition carried. The basic load for a combat-service support unit was considerably lower than that of the combat arms. However, the machine gunners were amazed at how much ammunition they could fire in just a few minutes. The crews quickly increased the amount of ammunition they carried in the gun trucks, covering the entire floor with ammunition cans (see Figure 19). Essentially, a gun truck took as much ammunition as

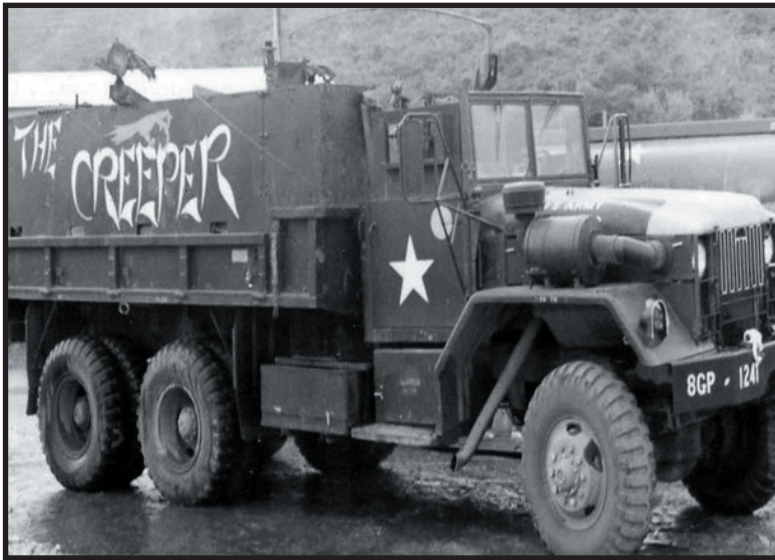
Figure 21. *The Creeper's* Bullet-Proof Windshields.

In 1969, gun trucks also received new bullet-proof windshields since the others were impractical. Instead of ports, the new windshields had pre-cut rectangles with slots for two 2-inch thick bullet-proof sheets of glass. These began to see widespread use on gun trucks. If damaged, the old glass could be slid out and be easily replaced with a new sheet.

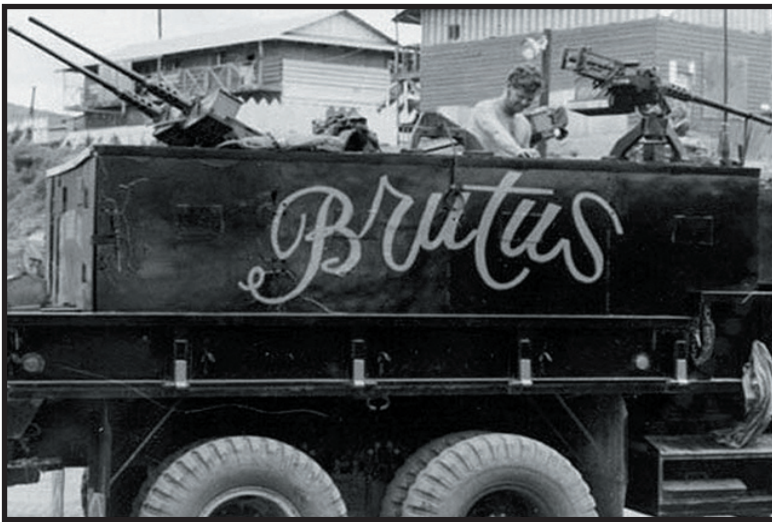
Figure 22. *Brutus*, Three .50 Calibers in a Big Iron Box.
